Manhole Inspection Summary

Manhole # S07UU_013MH

Location Address: **3023 GARRISON BLVD**

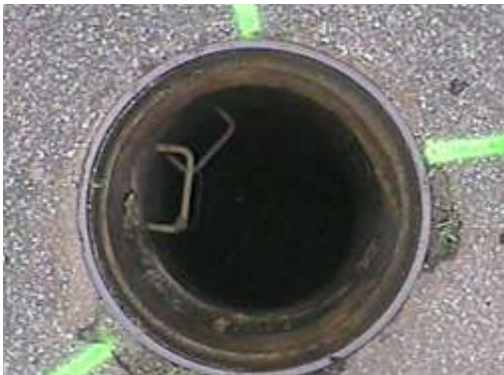
Defect 1

Offset: **2** (in.)

FRAME OFFSET

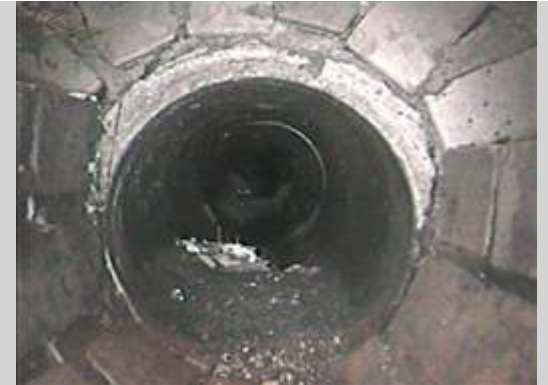
12 O'Clock Outflow

8 in. Circular Gravity Sewer
Pipe Out @ 12 O'Clock

Deposits: ☐ None ☐ Mud ☐ Sludge ☒ **Debris** ☐ Grease

Silt Depth: **0.5** (in.) Deposits Extent: **Light**

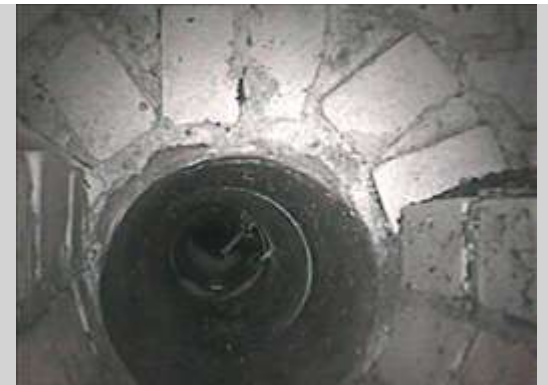
3 O'Clock Inflow

8 in. Circular Gravity Sewer
Pipe In @ 3 O'Clock

Deposits: ☒ **None** ☐ Mud ☐ Sludge ☐ **Debris** ☐ Grease

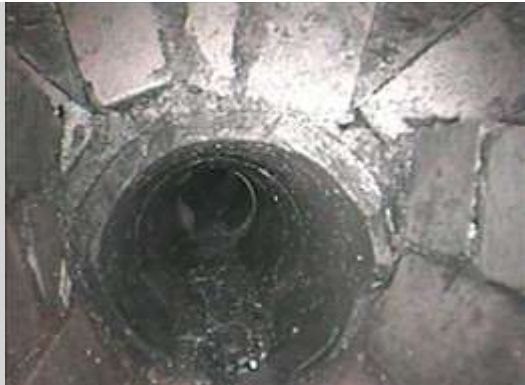
9 O'Clock Inflow

8 in. Circular Gravity Sewer
Pipe In @ 9 O'Clock

Deposits: ☐ None ☐ Mud ☐ Sludge ☒ **Debris** ☐ Grease

Silt Depth: **0.5** (in.) Deposits Extent: **Light**
